Technical Report CERC-96-8
September 1996

Periodic Inspection of Burns Harbor North Breakwater, Indiana

Report 1 Base Conditions

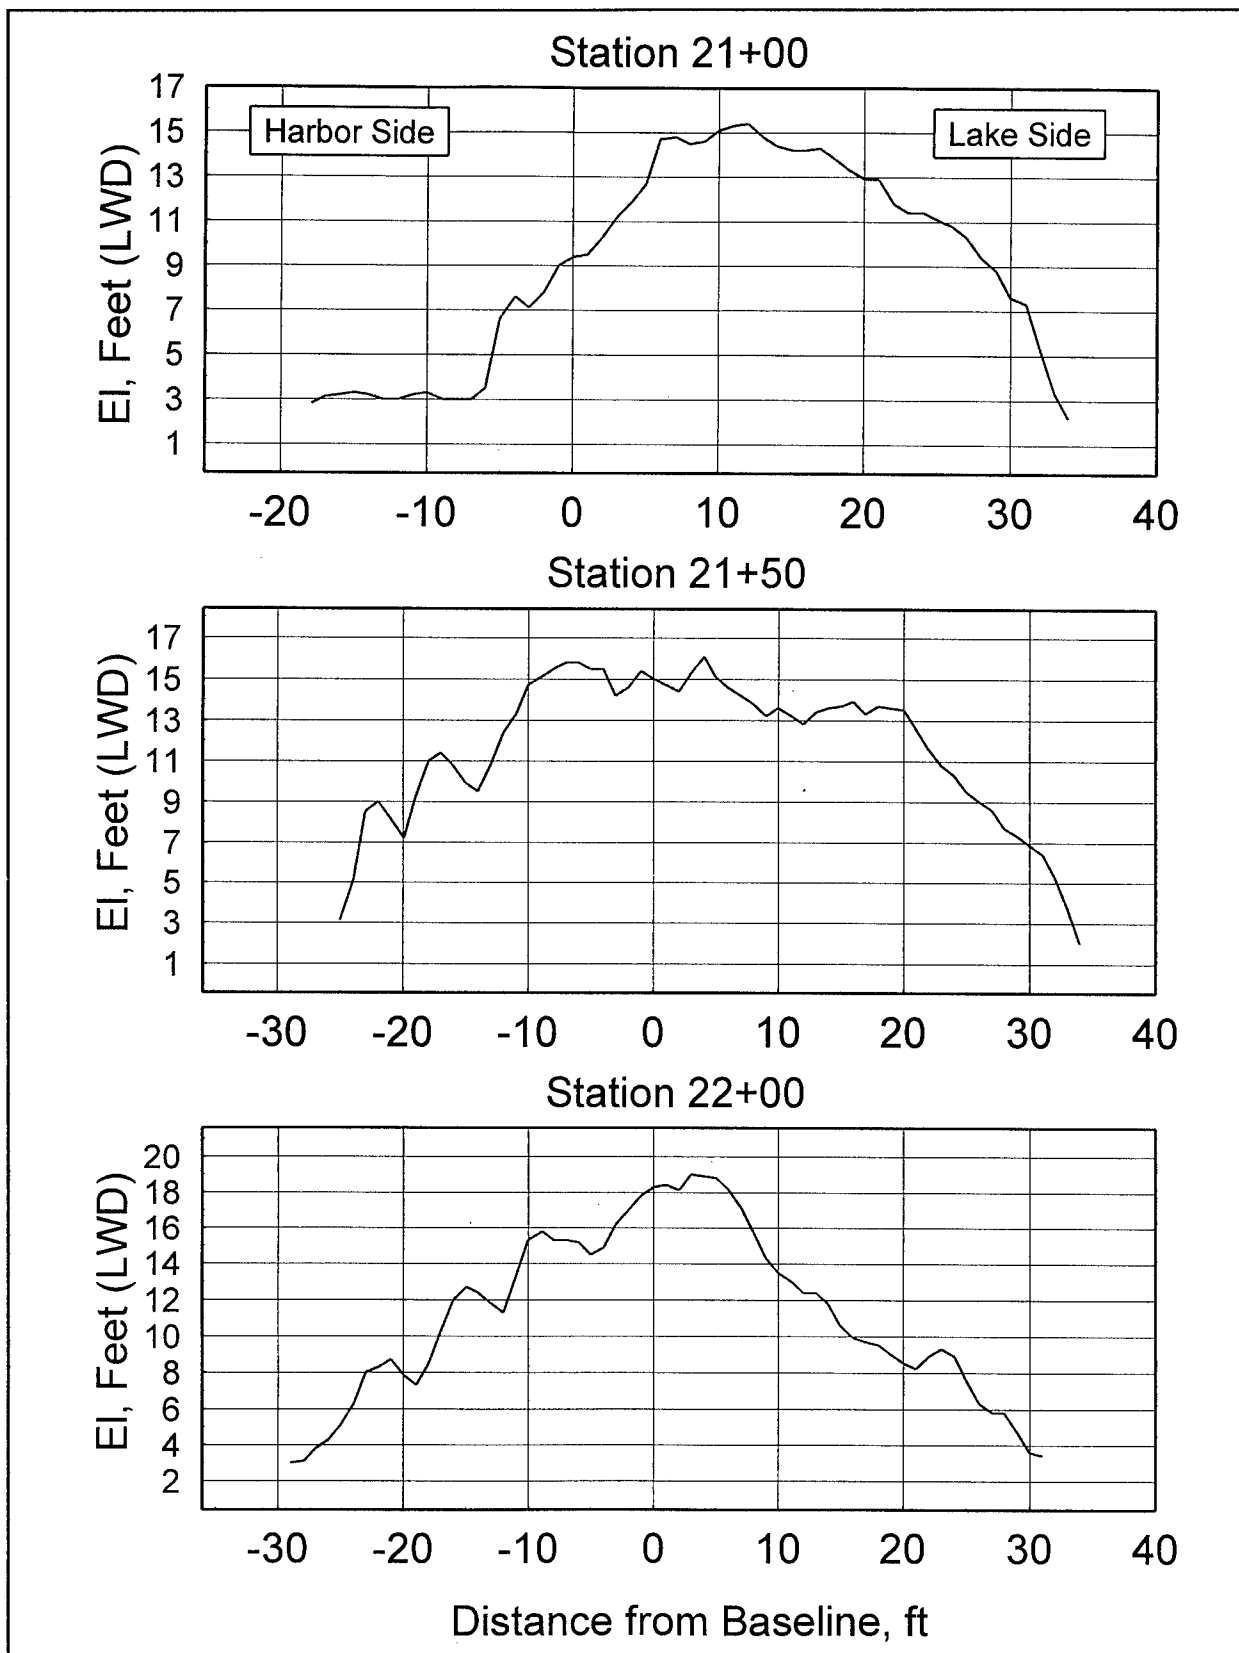
Figure B19. Cross sections of Burns Harbor North Breakwater, sta 21+00, 21+50, and 22+00

This appendix presents cross sections of the Burns Harbor North Breakwater. Cross sections were developed using the digital terrain model (DTM) grid as stated in the main text of this report. They were obtained at 0.3-rad (15-deg) intervals around the head of the breakwater and 15.2-m (50-ft) intervals along the trunk as shown in Figure 10 in the main text of this report. Elevations shown are in feet referred to low water datum (lwd). To convert them to meters, multiply by 0.3048. Distances from the baseline also are shown in feet and may be converted to meters using the same factor. The baseline established was the approximate center line of the breakwater. Negative distances are measured relative to the harbor side of the baseline and positive distances are measured relative to the lake side of the baseline.

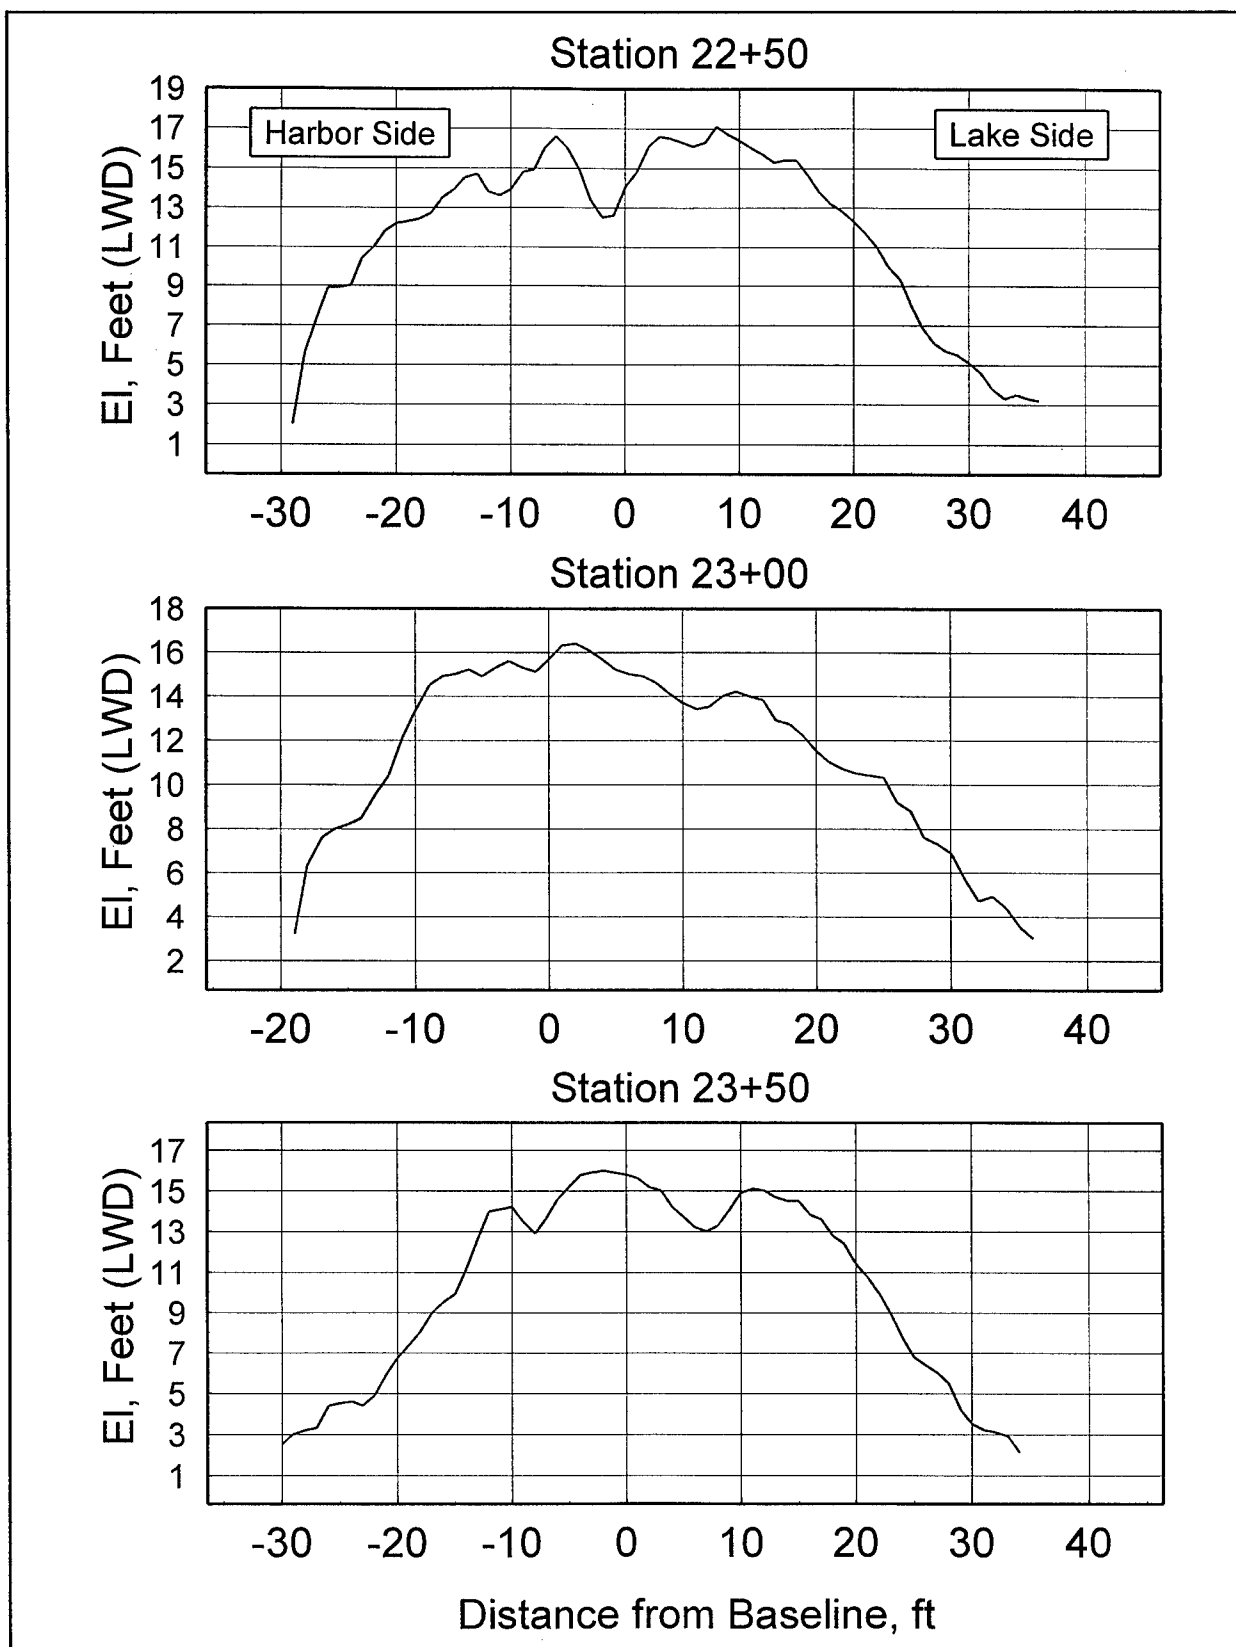
Figure B20. Cross sections of Burns Harbor North Breakwater, sta 22+50, 23+00, and 23+50

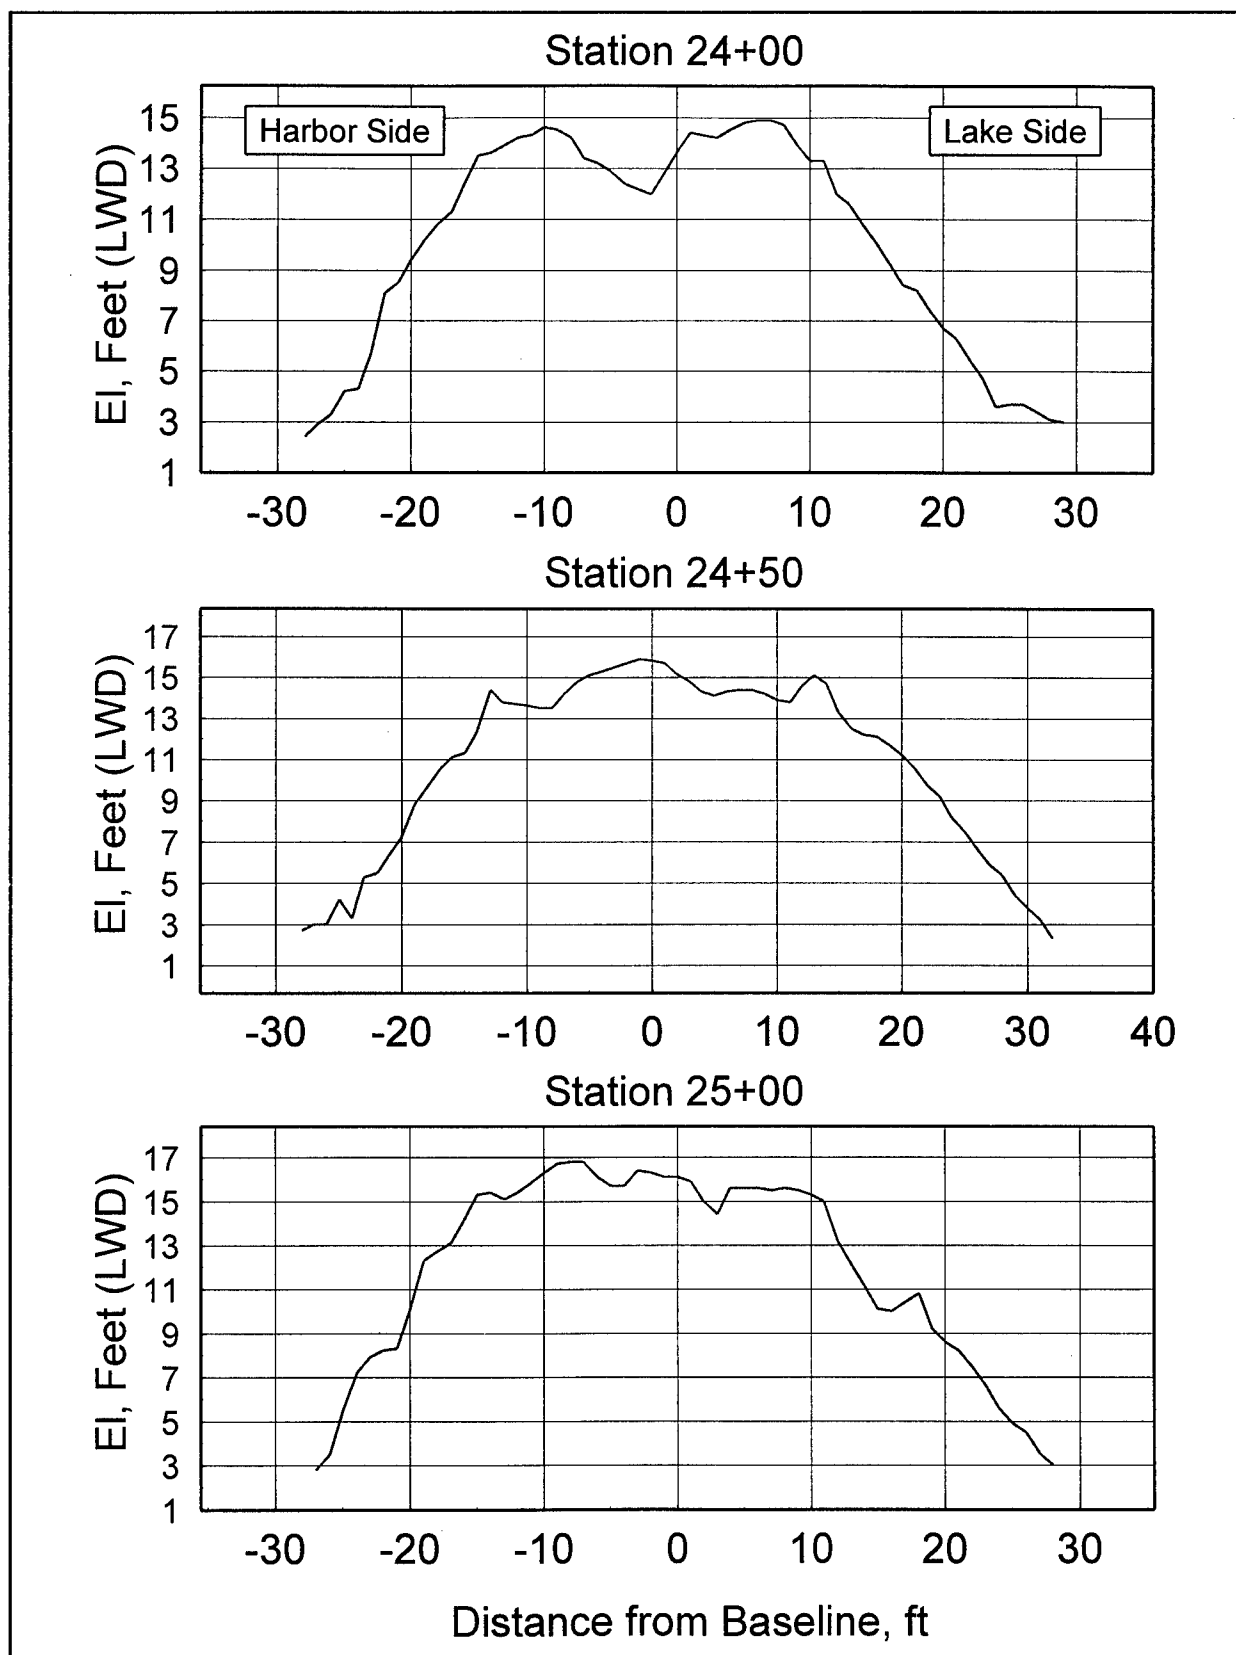
Figure B21. Cross sections of Burns Harbor North Breakwater, sta 24+00, 24+50, and 25+00

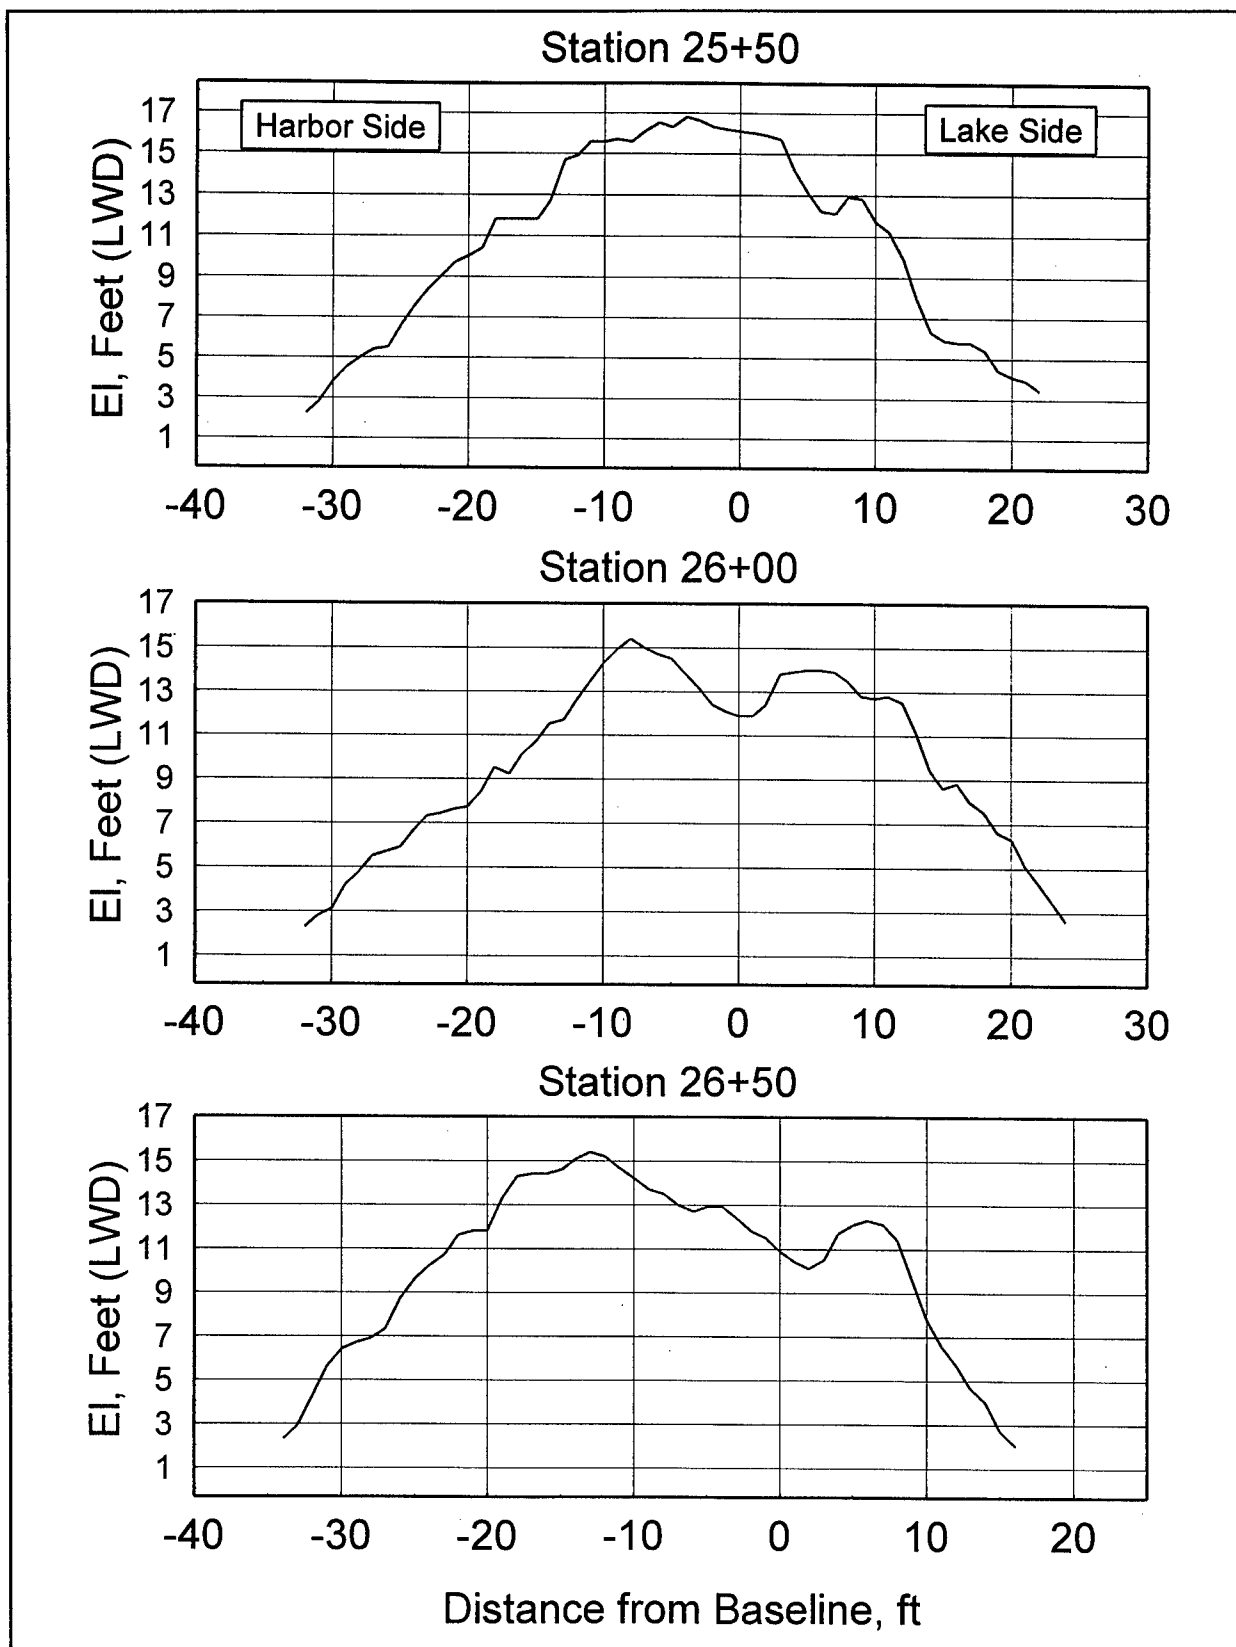
Figure B22. Cross sections of Burns Harbor North Breakwater, sta 25+50, 26+00, and 26+50

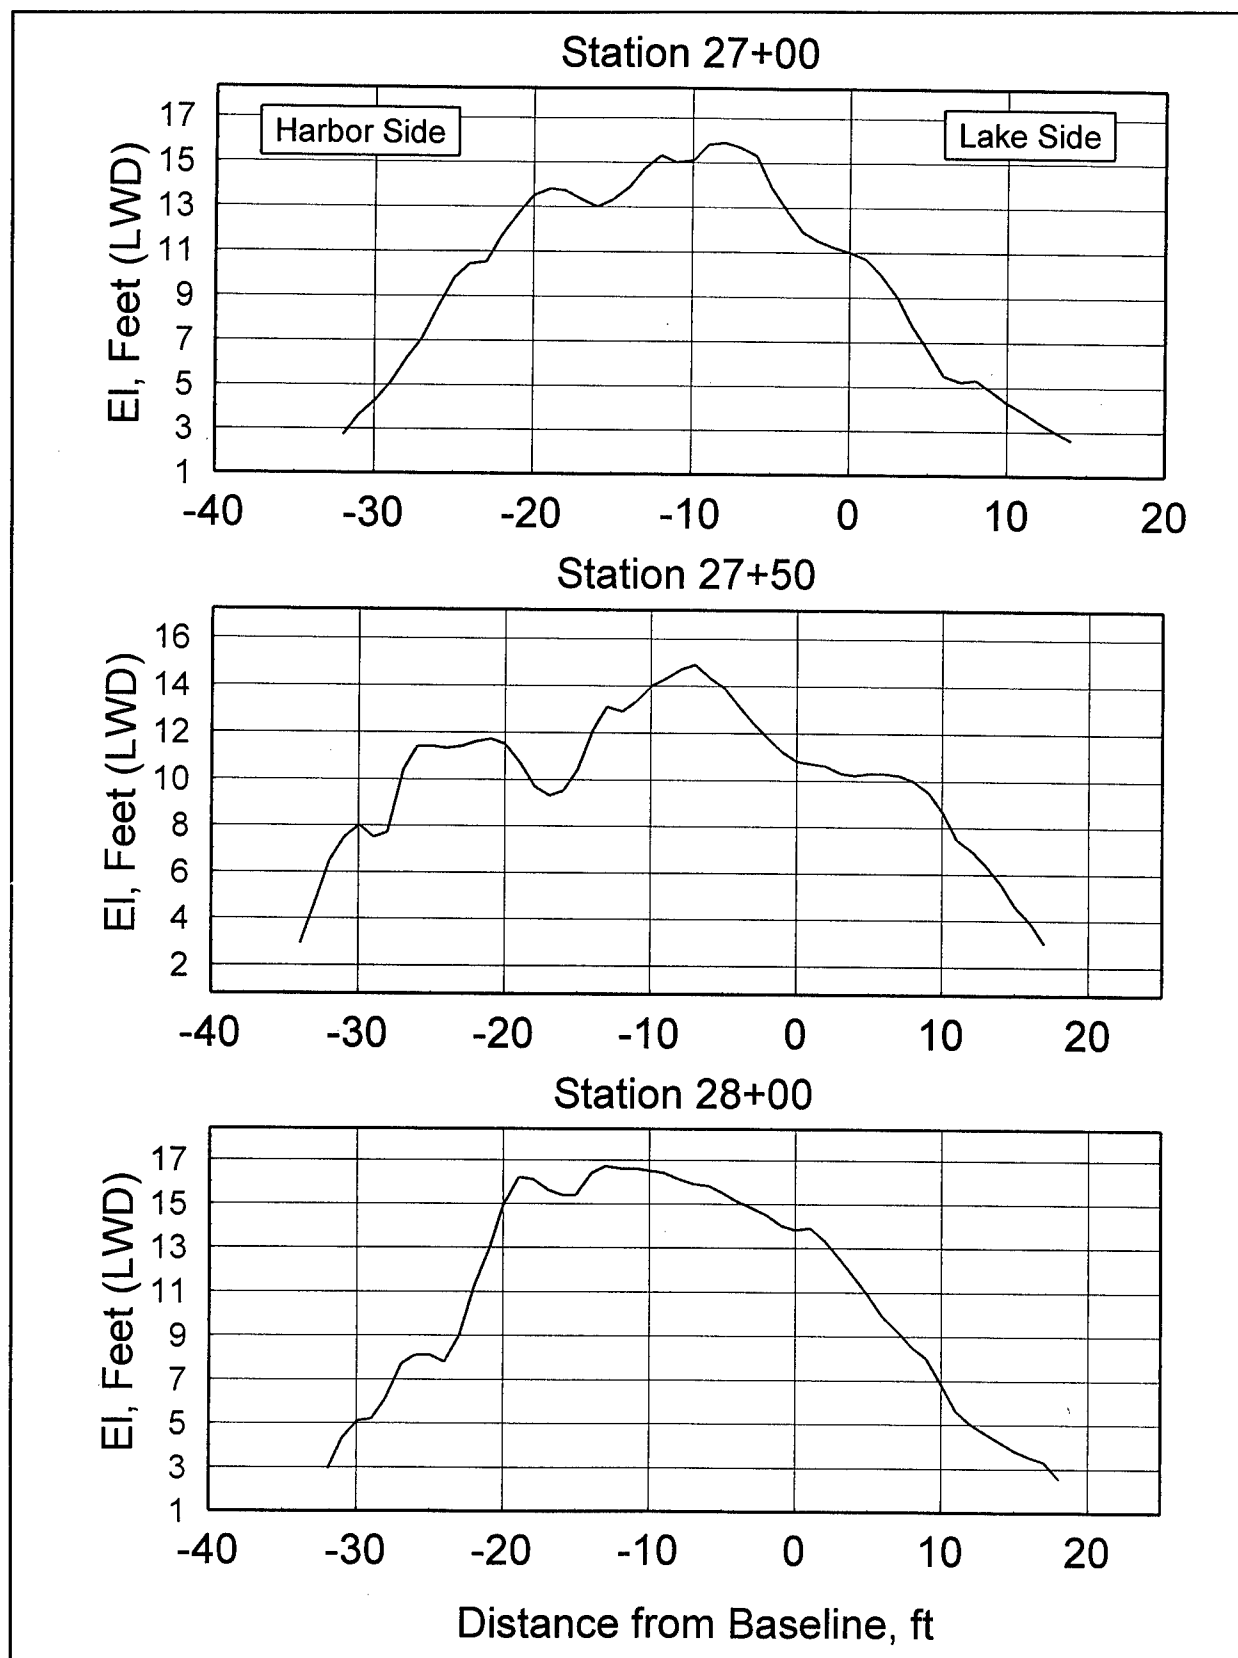
Figure B23. Cross sections of Burns Harbor North Breakwater, sta 27+00, 27+50, and 28+00

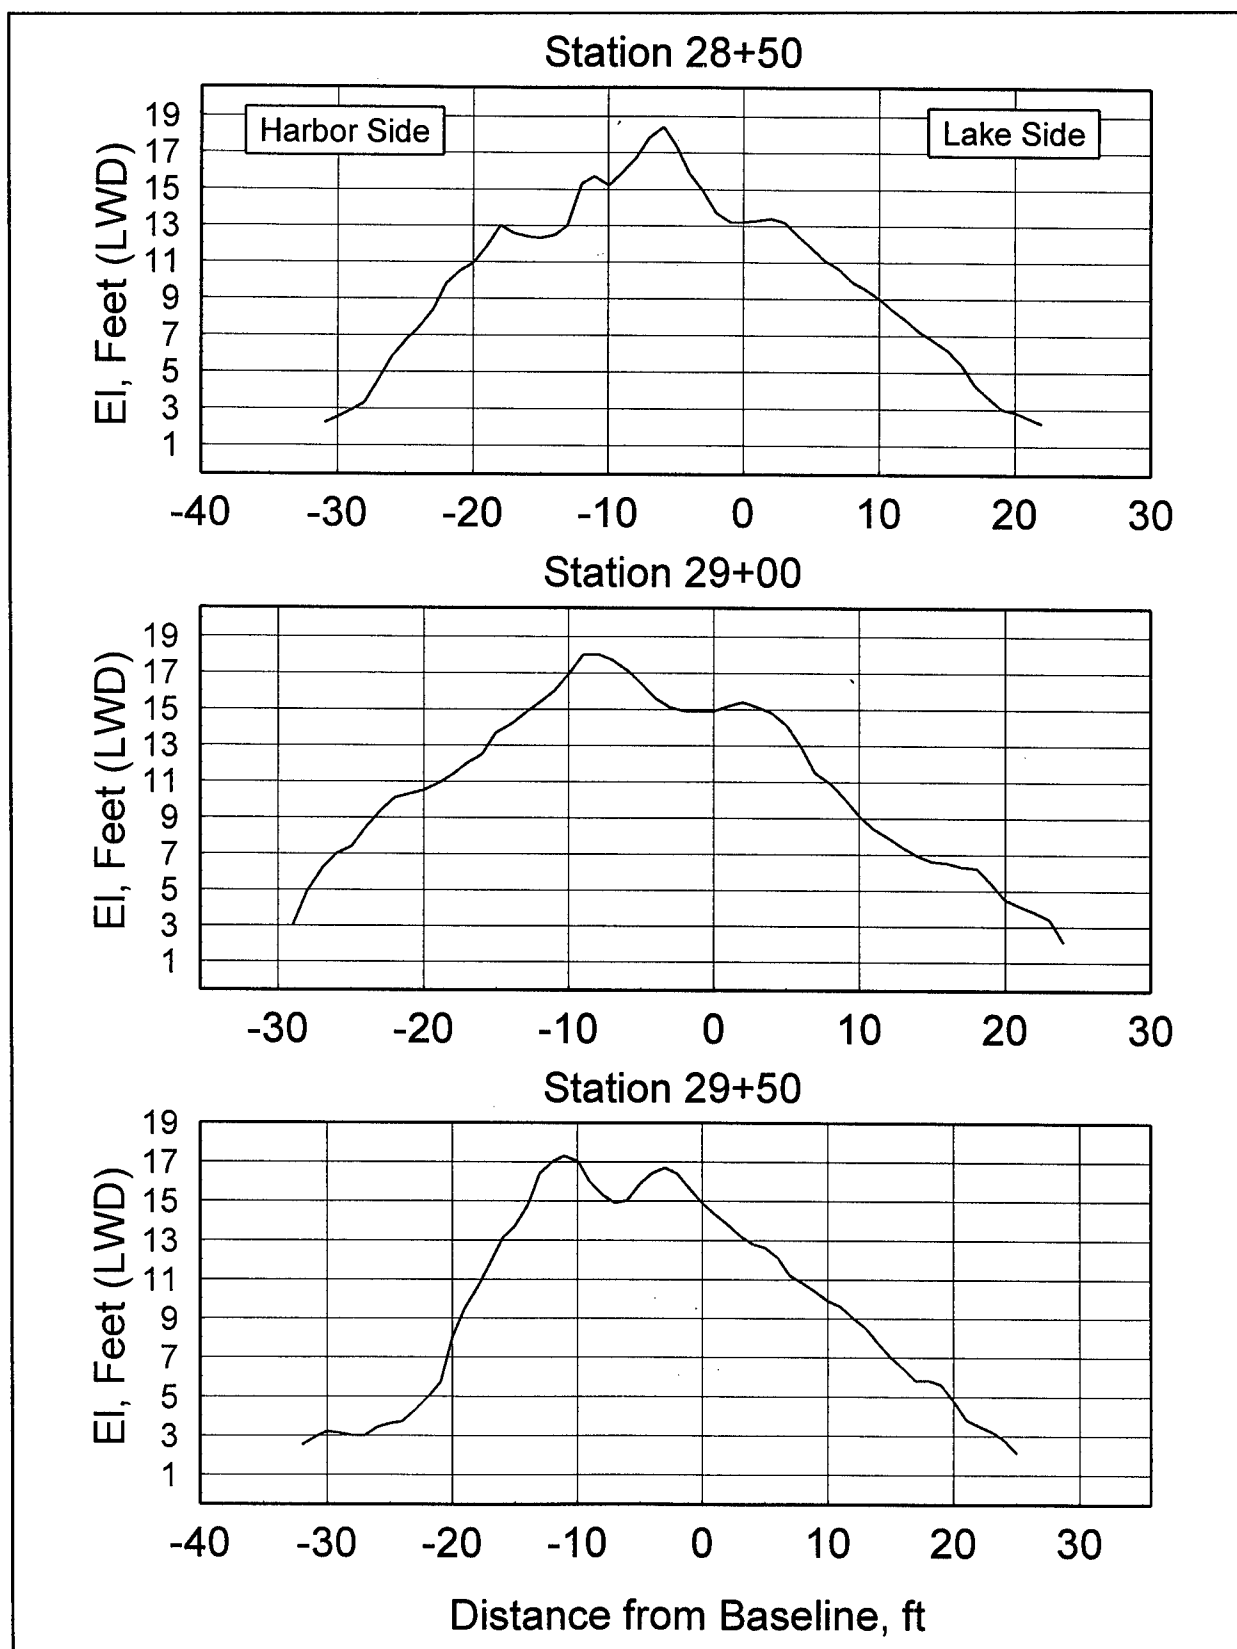
Figure B24. Cross sections of Burns Harbor North Breakwater, sta 28+50, 29+00, and 29+50

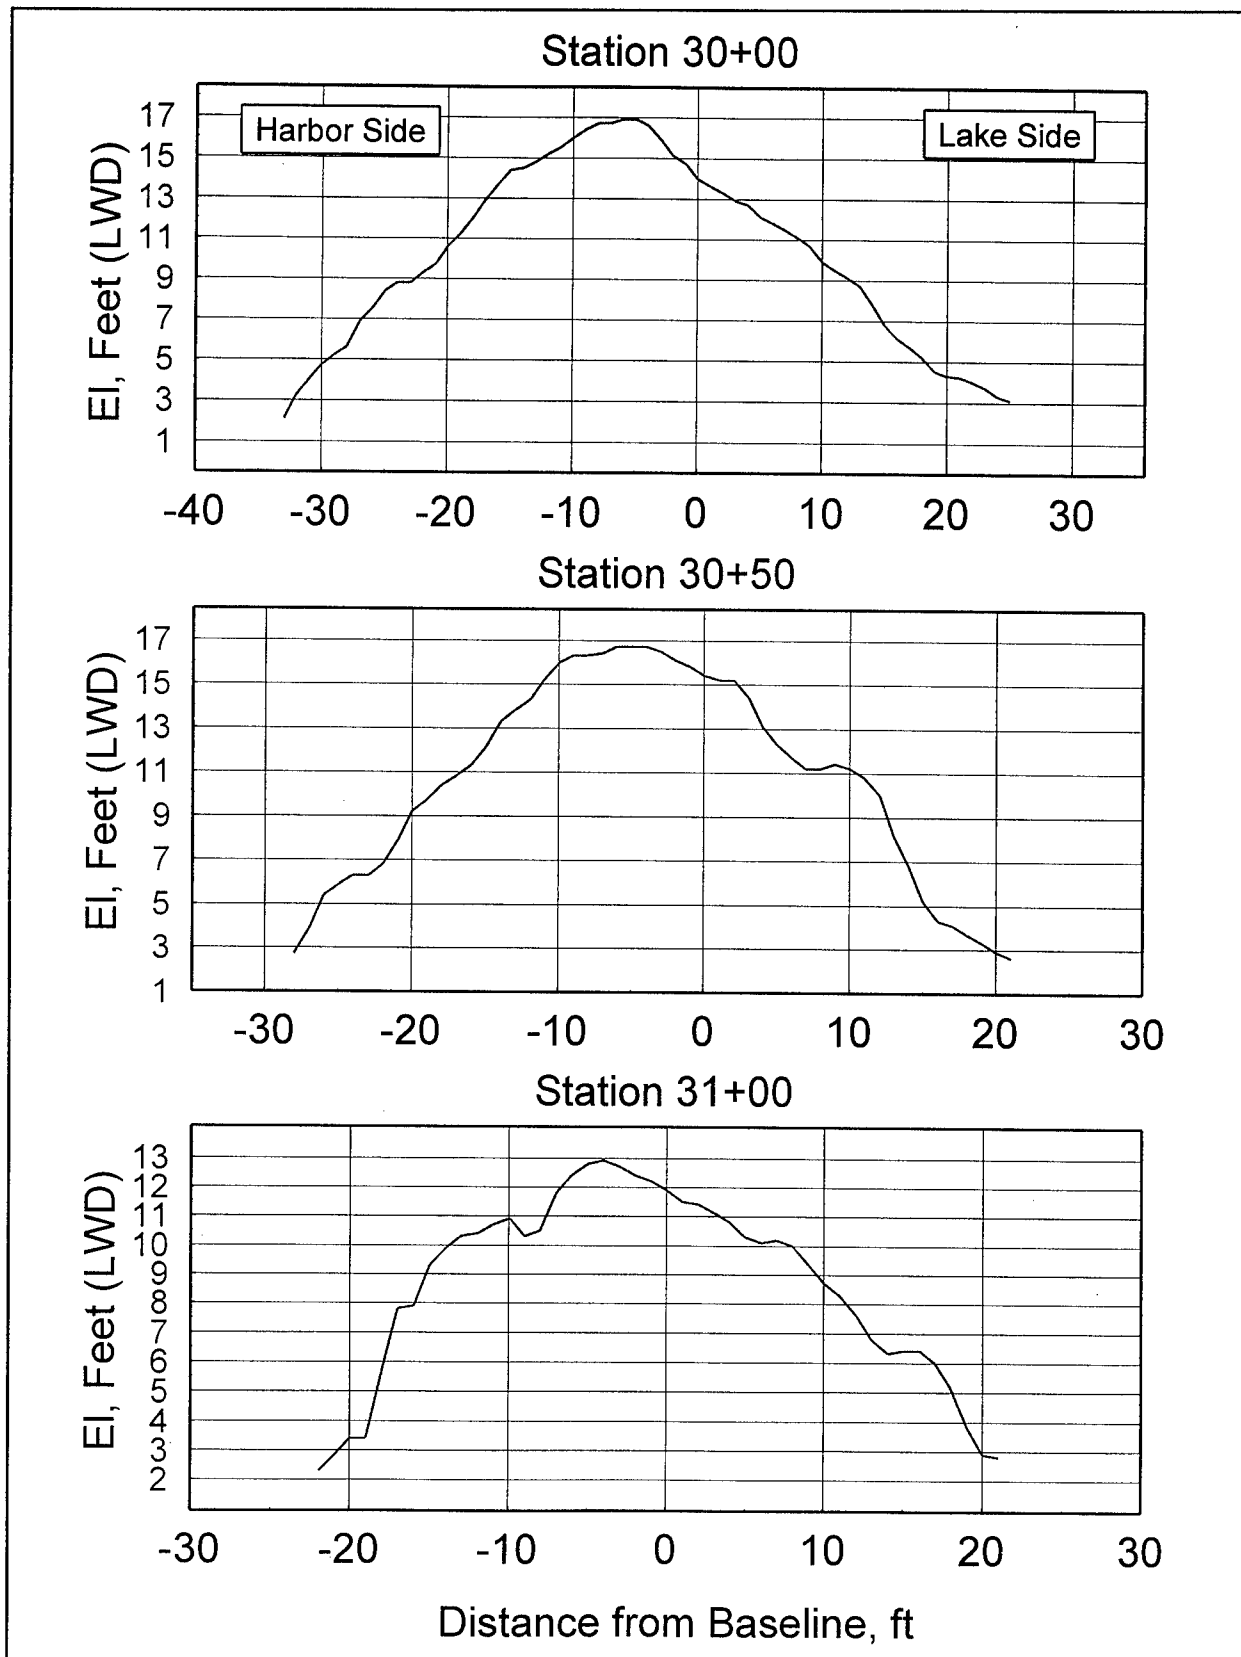
Figure B25. Cross sections of Burns Harbor North Breakwater, sta 30+00, 30+50, and 31+00

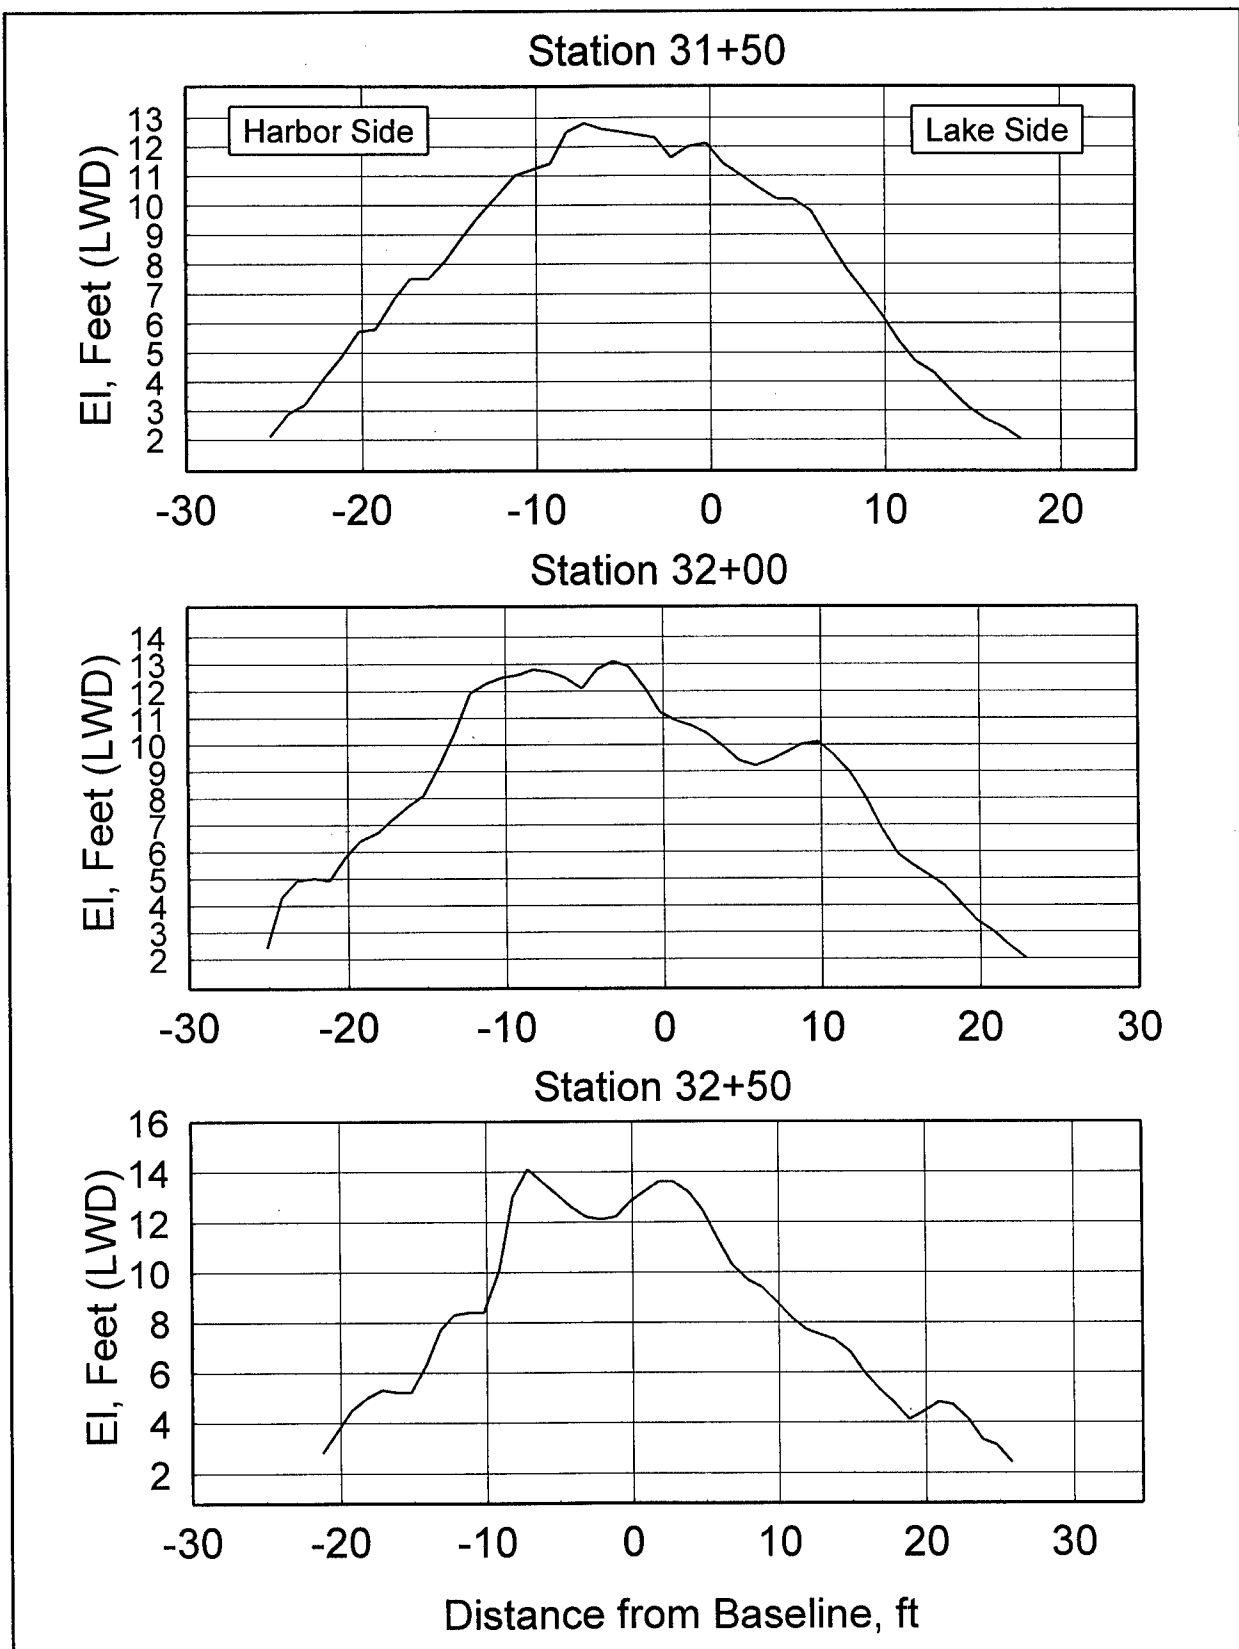
Figure B26. Cross sections of Burns Harbor North Breakwater, sta 31+50, 32+00, and 32+50

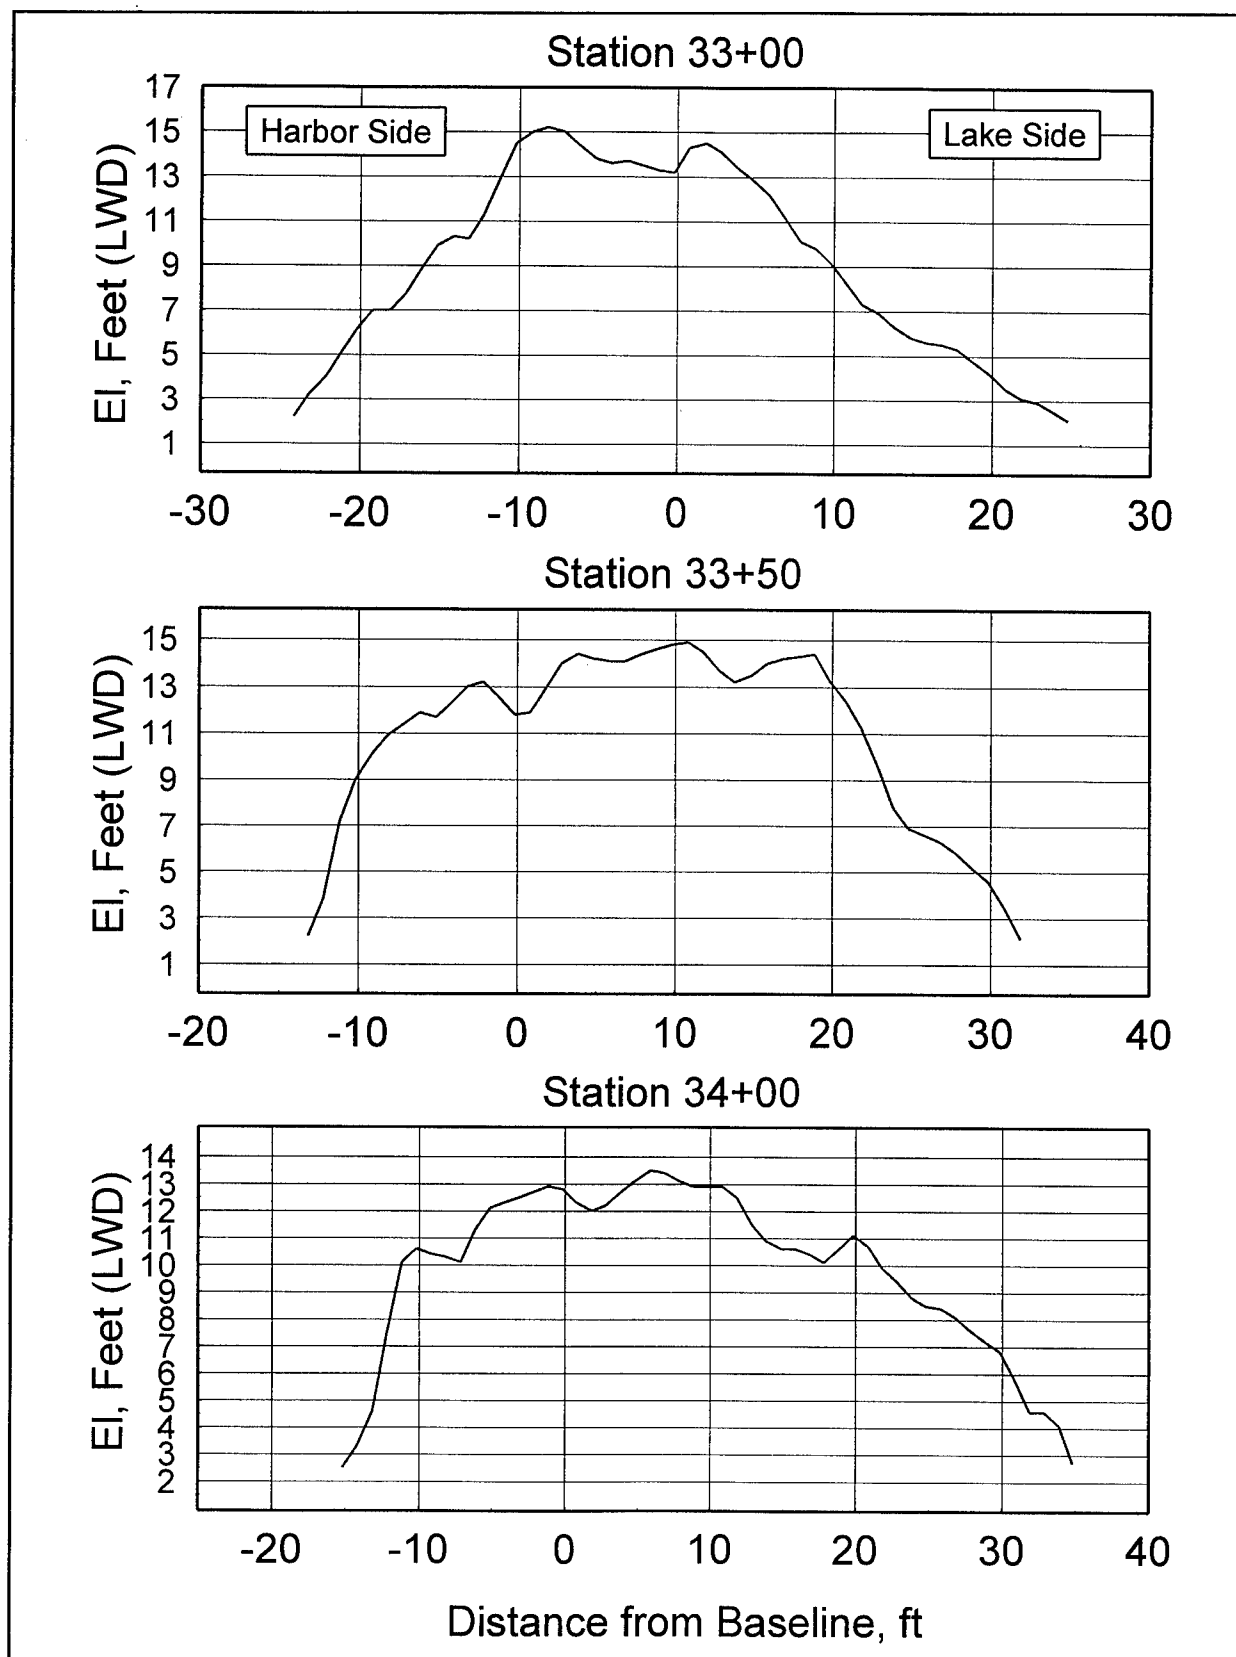
Figure B27. Cross sections of Burns Harbor North Breakwater, sta 33+00, 33+50, and 34+00

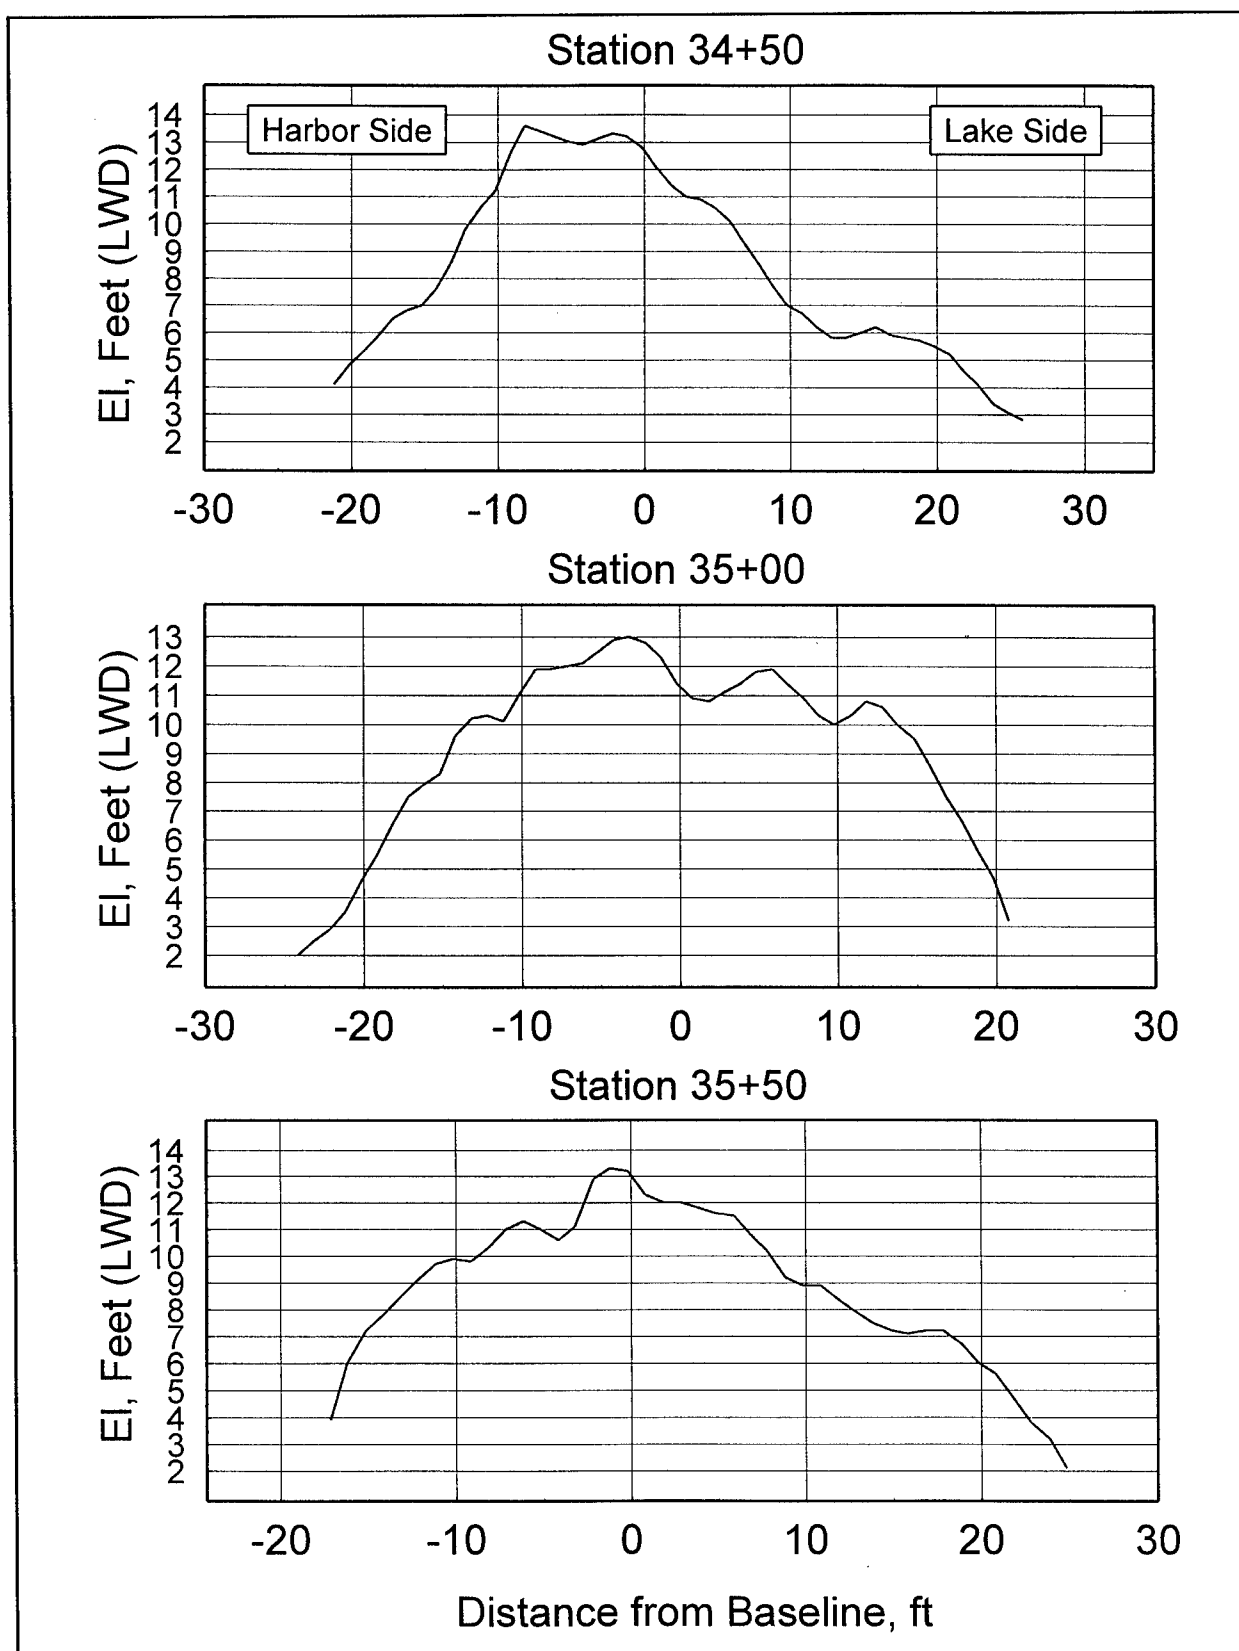
Figure B28. Cross sections of Burns Harbor North Breakwater, sta 34+50, 35+00, and 35+50

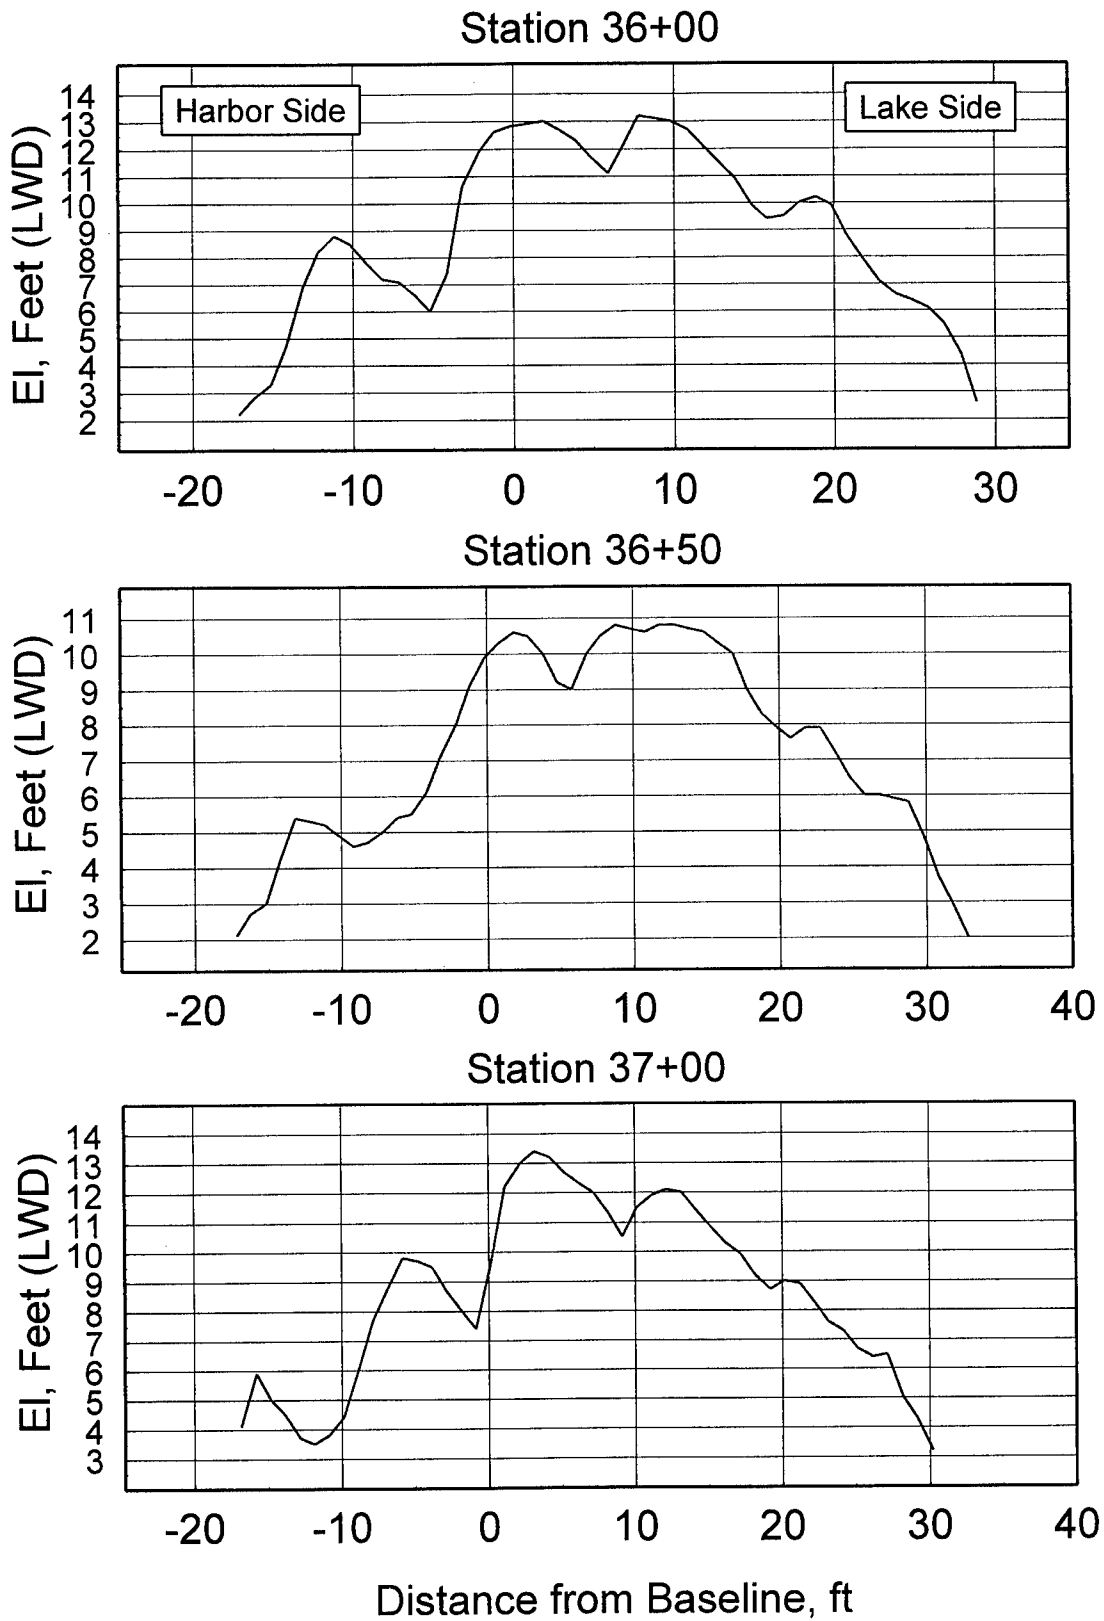
Figure B29. Cross sections of Burns Harbor North Breakwater, sta 36+00, 36+50, and 37+00
